**MINUTES OF MEETING  
CAVE ROCK ESTATES GENERAL IMPROVEMENT  
DISTRICT**

# Technical Memorandum

To: Chris LaCasse, Nevada Division of State Lands  
From: Nevada Tahoe Conservation District  
Date: 12/4/2024  
Re: Cave Rock General Improvement District Existing Conditions Assessment Memo

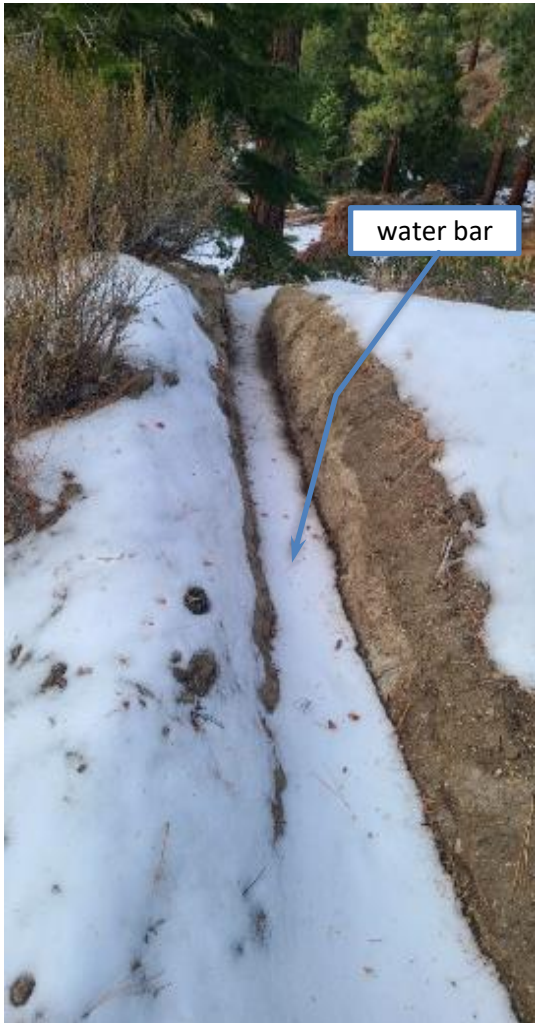
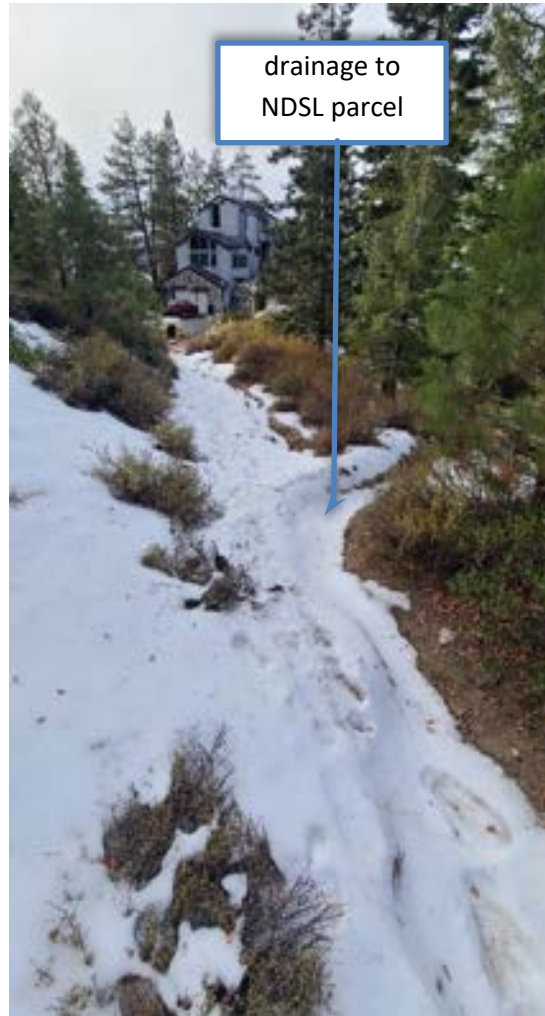
## Area of Concern #1

When the neighborhood was designed, a road grade was installed on a US Forest Service parcel (APN 1418-27-812-010) to continue building homes off the cul de sac of Winding Way/Crane Court. The road grade has become a hiking trail and runoff is eroding the trail, eroding NDSL parcel (APN 1418-27-712-016 or Tahoe 486-0), and eroding the Winding Way/Crane Court roadside ditch. The CRGID has installed coir logs, water bars and two dirt drainage ditches on NDSL property to alleviate the stormwater runoff onto Winding Way/Crane Court.

Remove the road grade and revegetate the area, using coir logs to stabilize the site. Remove and restore the 1-foot wide and 1-foot-deep dirt drainage ditches with rock lined drainage ditches and add water bars where necessary to convey runoff.

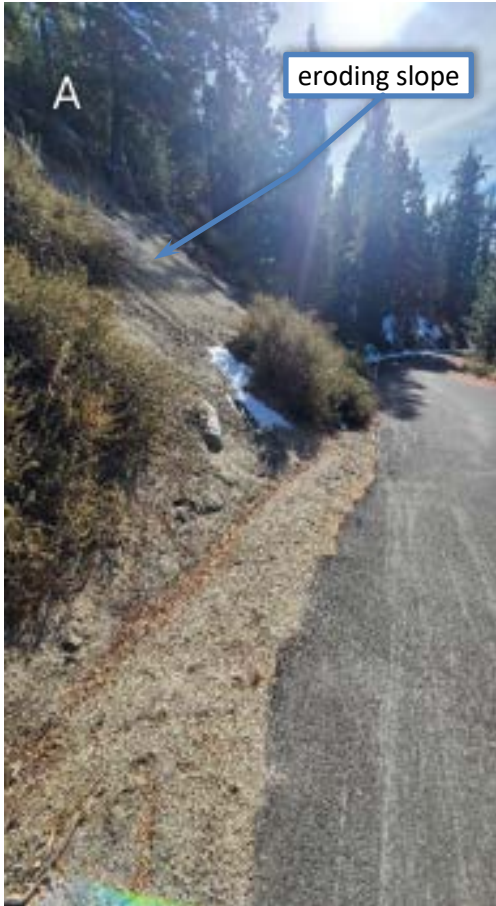
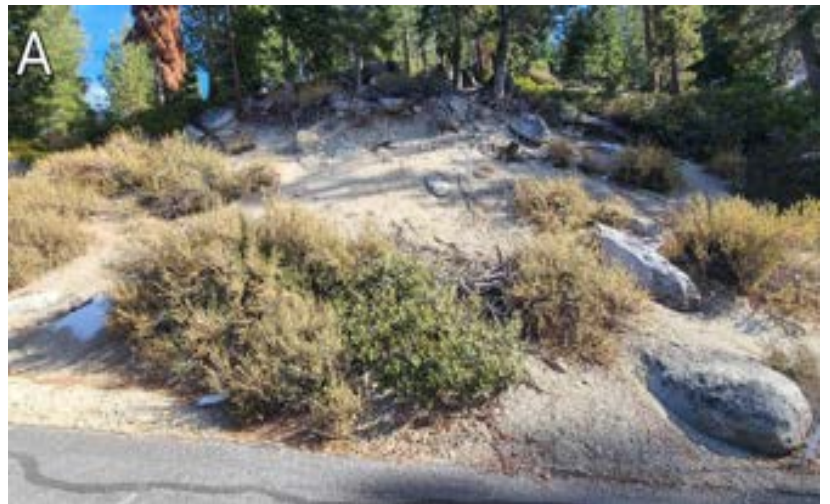
## Area of Concern #2

Eroding hillslope into the Winding Way/Crane Court roadside ditch

Remove excess sediment at base of slope, stabilize slope with coir logs and erosion control blankets.

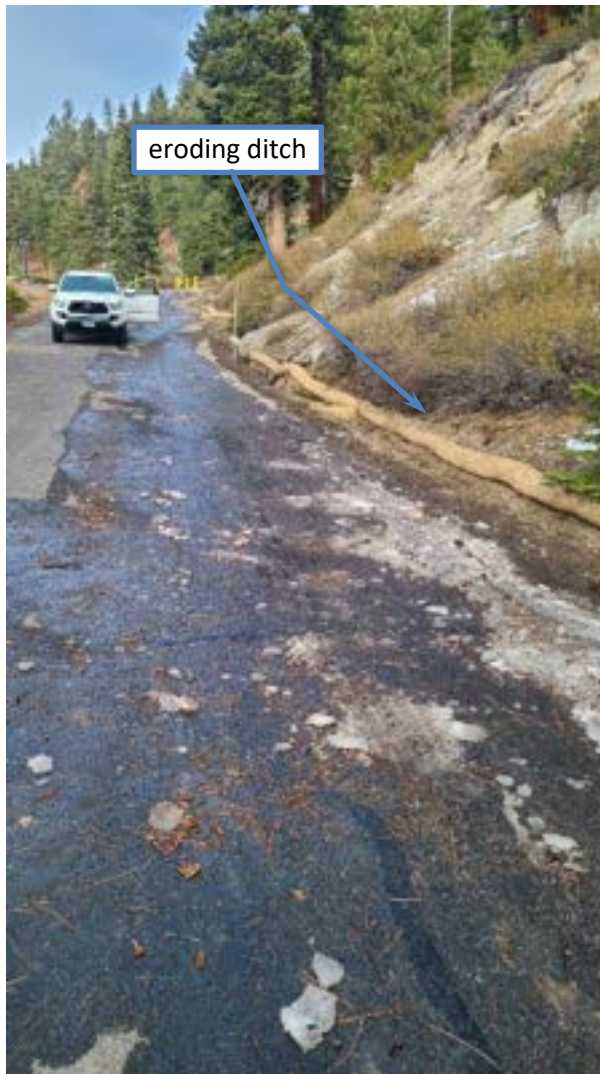
eroding ditch

road integrity

Upland road grade and Winding Way/Crane Court road runoff is eroding roadside ditch, compromising integrity of the road itself.

Regrade the ditch, rock line the ditch, and install a series of sediment cans to reduce maintenance on the ditch.

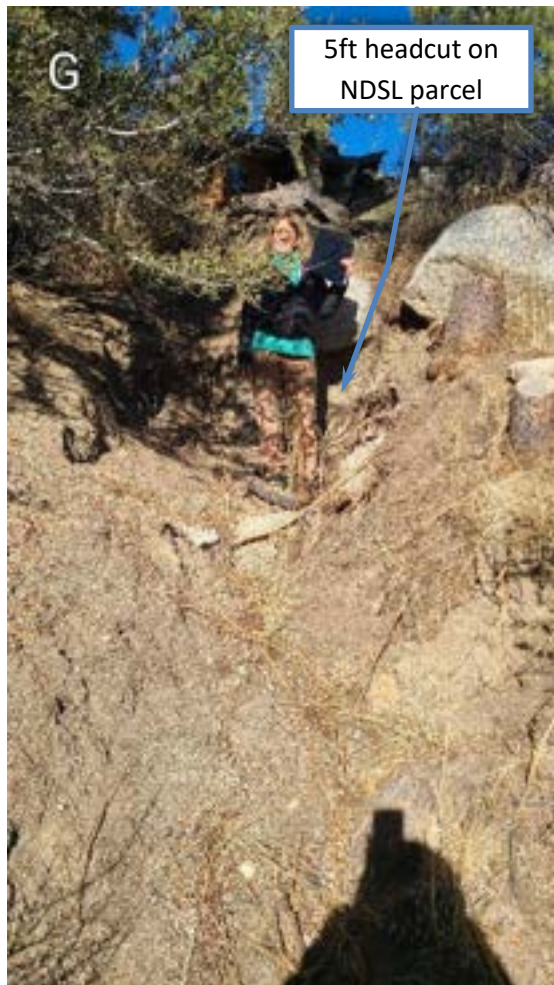
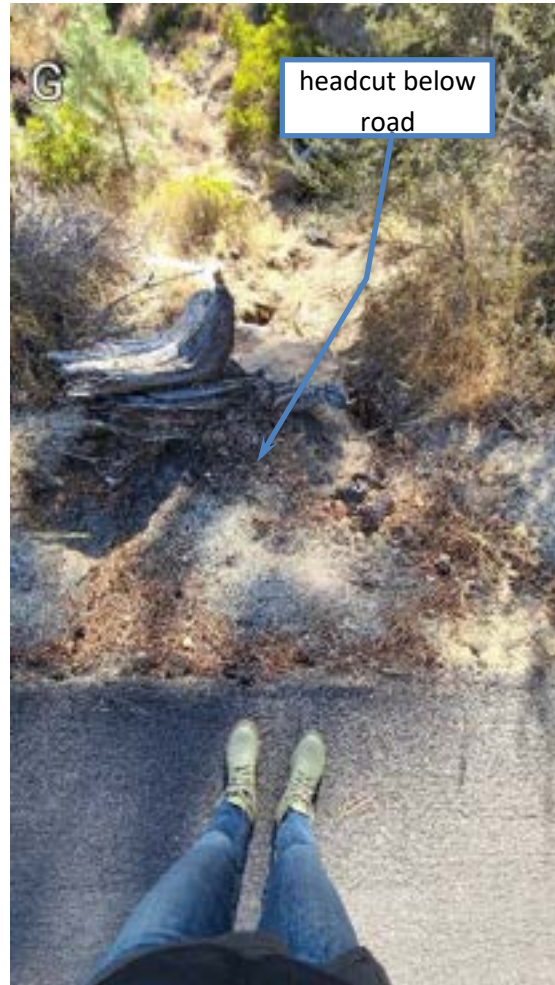
## Area of Concern #3

Robin Circle road runoff is not accumulating at the drainage inlet and conveyance pipe along the inside of the road, probably due to the pipe being clogged. The outside of the road has no AC berm (curb & gutter), so when road runoff accumulates, it is discharging down the natural hillslope, NDSL parcel (APN 1418-27-810-007). The hillslope has a 5-foot headcut which could compromise the road integrity and the 12" CMP conveyance pipe outlet cannot be located.

Replace the drainage inlet with a sediment can equipped with sump and install a new conveyance pipe. Perform a hydrologic analysis to determine the appropriate placement for the sediment can and pipe size, adding a rock line ditch below the conveyance pipe outlet. Restore the 5-foot headcut with native fill/rocks, revegetate the hillslope and stabilize it with coir logs and erosion control blanket. If all road runoff is directed to the sediment can, the road integrity should be fine. If not, then install rolled curb & gutter on the outside of the road to prevent hillslope and road damage.

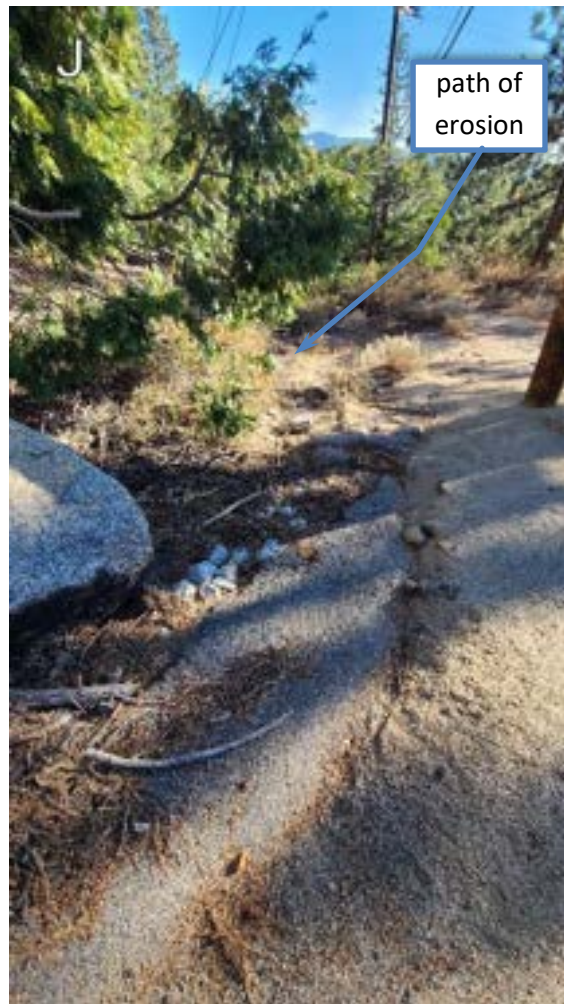
## Area of Concern #4

Winding Way road runoff overwhelms or bypasses the drainage inlet on Winding Way and is eroding the roadside. The existing rock lined ditch has been filled in with debris and is no longer functioning as designed. Eventually the runoff reaches a hillside and it is causing erosion near the hiking trails and onto a US Forest Service parcel (APN 1418-00-002-009).

1. Install a double catch basin with sump to increase runoff and large debris retention
2. Add vertical L curb & gutter to redirect runoff back to Winding Way
3. Reestablish the rock lined ditch behind the curb & gutter
4. Revegetate the area and stabilize the slope with coir logs and erosion control blankets, both private and USFS parcel

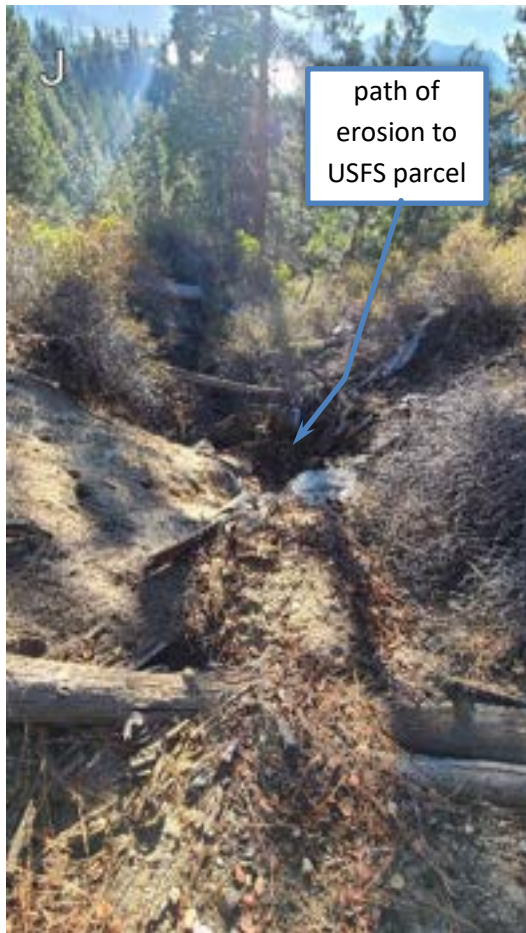
Road runoff is eroding the hillslope on private and US Forest Service parcel (APN 1418-00-002-009).

Due to steep slopes and no equipment access route to the drainage route, slope stabilization using coir logs and erosion control blankets where possible are the best retrofit option. Stormwater infrastructure along Winding Way should alleviate the amount of runoff onto the parcels and the slope stabilization should help aggregate material in the drainage routes.

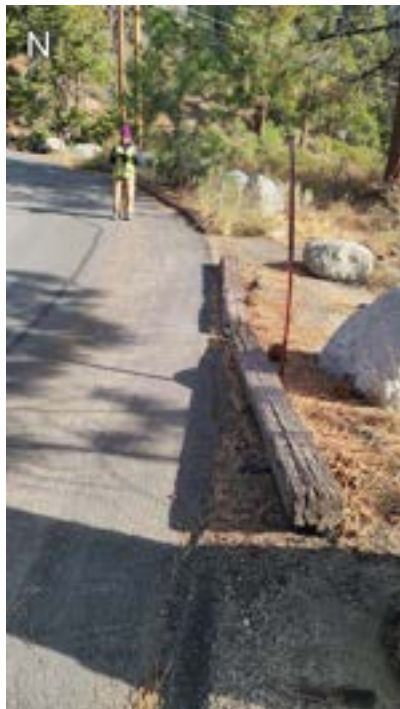
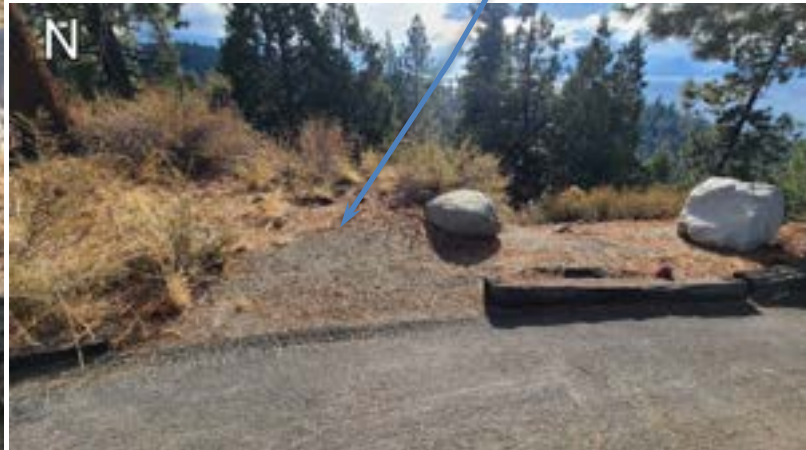
path of erosion

Missing AC berm and railroad ties along Winding Way allow road runoff to exit the road and flow down the hillslope creating erosion at 1339 Winding Way.

Install new L vertical curb and gutter to keep road runoff flowing down Winding Way

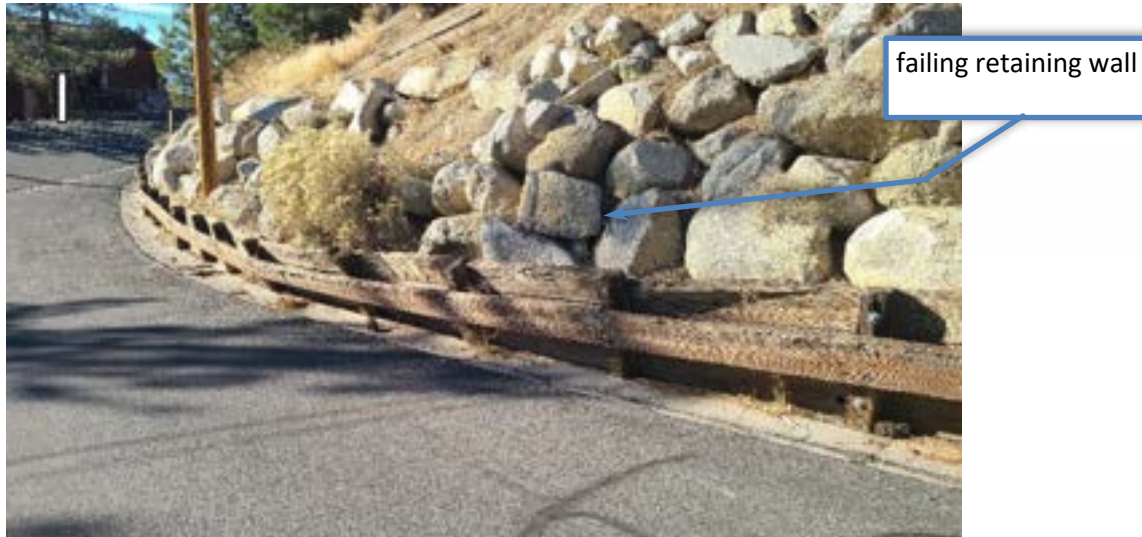
## Area of Concern #5

Failing 3-foot wood retaining wall along Gull Court

Remove excess sediment from hillslope collapse, replace rocks and install concrete retaining wall

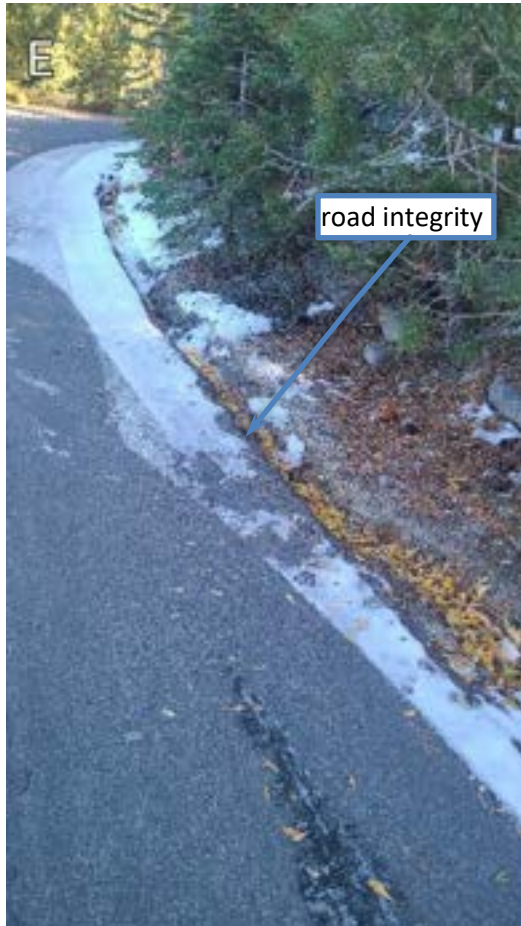
## Area of Concern #6

Chukar Drive road runoff is eroding the roadside ditch and compromising the road integrity

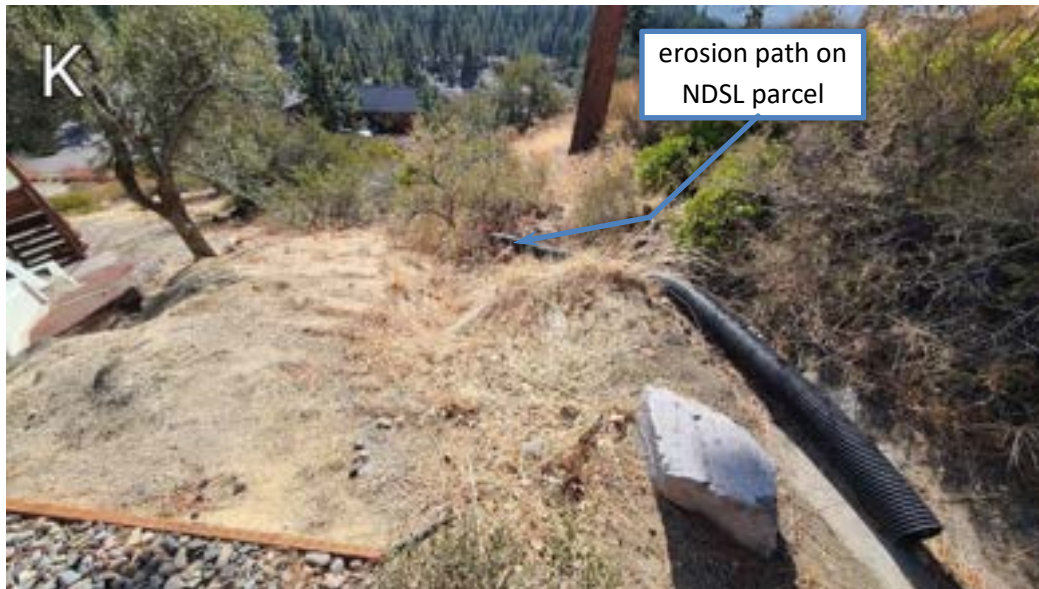
## Area of Concern #7

Wren Circle road runoff accumulates and discharges off the end of the cul de sac creating hillslope erosion onto an NDSL parcel (APN 1418-27-810-014).

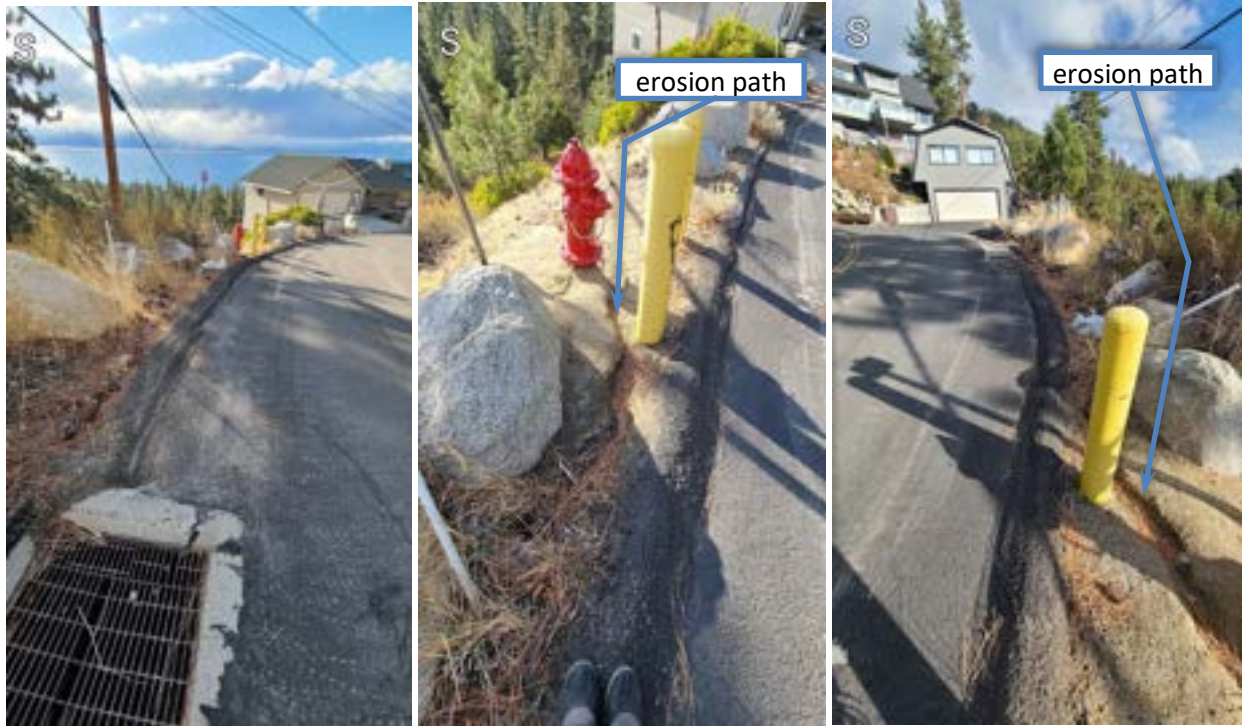
## Area of Concern #8

Cave Rock Drive road runoff bypasses or overwhelms the drainage inlet, continues downhill bypassing the old AC berm and is eroding the hillslope onto USFS parcel (APN 1418-00-002-009).

Install a double catch basin with sump along with vertical curb and gutter. The double catch basin will attenuate the flow and large debris, and the vertical curb and gutter will convey the road runoff to the double catch basin. The vertical curb and gutter below the double catch basin will prevent runoff eroding the USFS parcel hillslope by keeping the runoff moving down Cave Rock Drive.

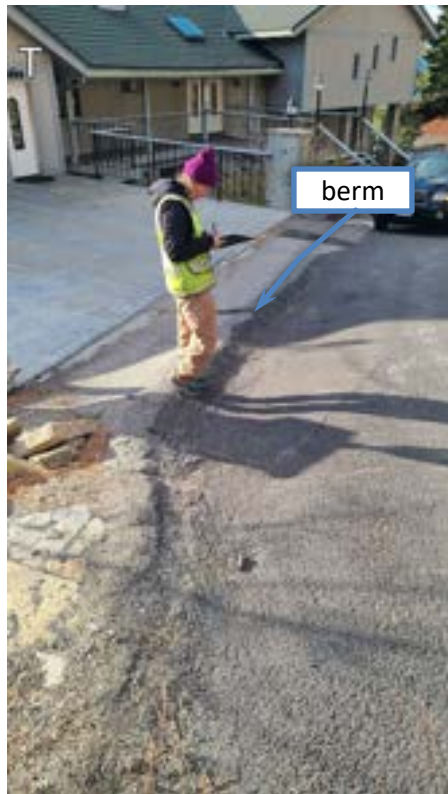
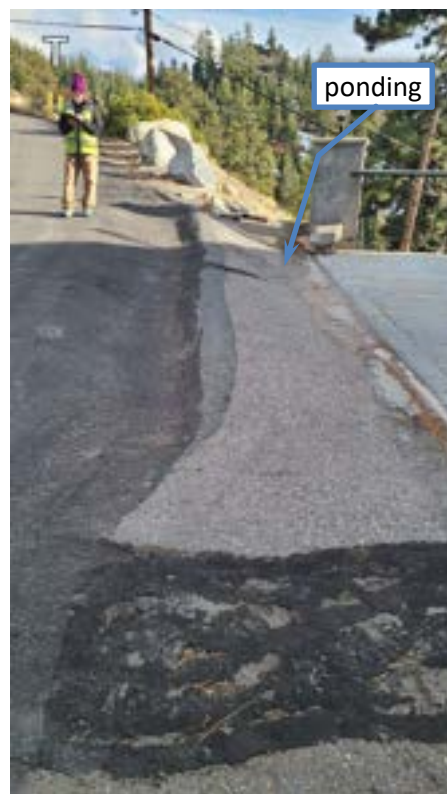
Cave Rock Drive road runoff conveys along the edge of the road into an AC swale at 1322 Cave Rock Drive. If the runoff overtops the AC swale, the runoff will pond on 1322 Cave Rock Drive's driveway until it ponds deep enough to continue flowing downhill along the road edge. NTCD believes a homeowner and/or CRGID discussion is warranted to reveal any issues at this parcel, which could result in additional stormwater infrastructure not included in the cost estimate.

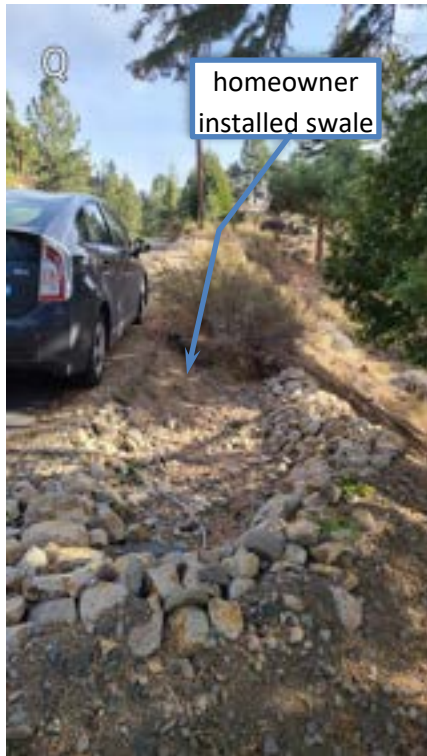
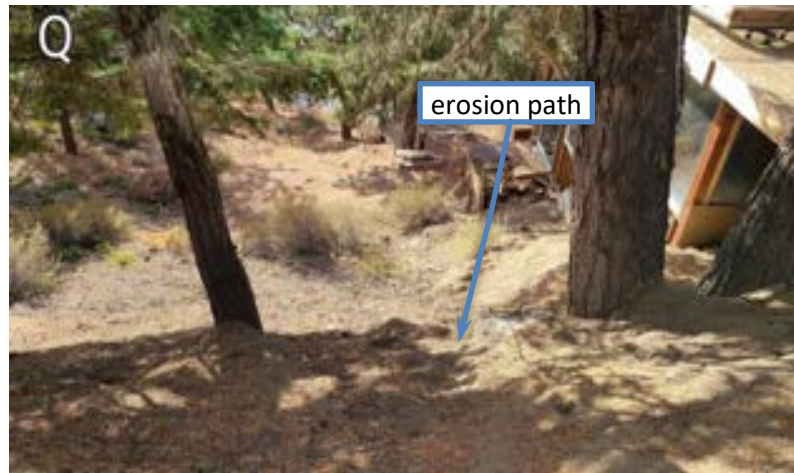
## Area of Concern #9

After AC berm along Winding Way ends, the Winding Way road runoff discharges onto 1331 Winding Way, eroding the slope and flooding the home on the property. The property owner constructed a rock line swale to attenuate the flow and route the runoff away from the home foundation.

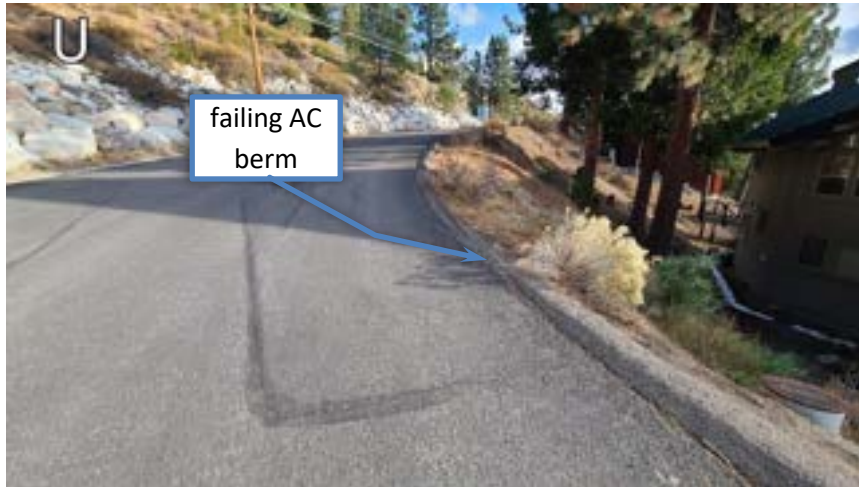
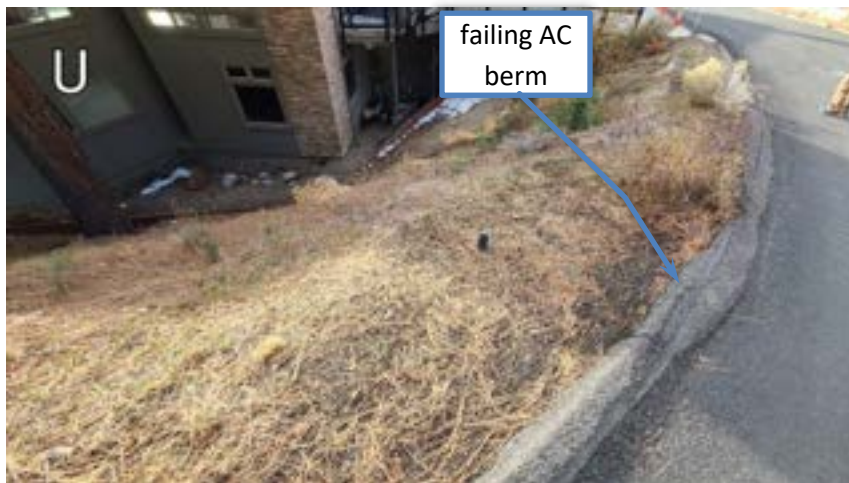
## Area of Concern #10

The AC berm is failing at 1318 Cave Rock Drive and road runoff is eroding the hillslope, with potential to flood the property.

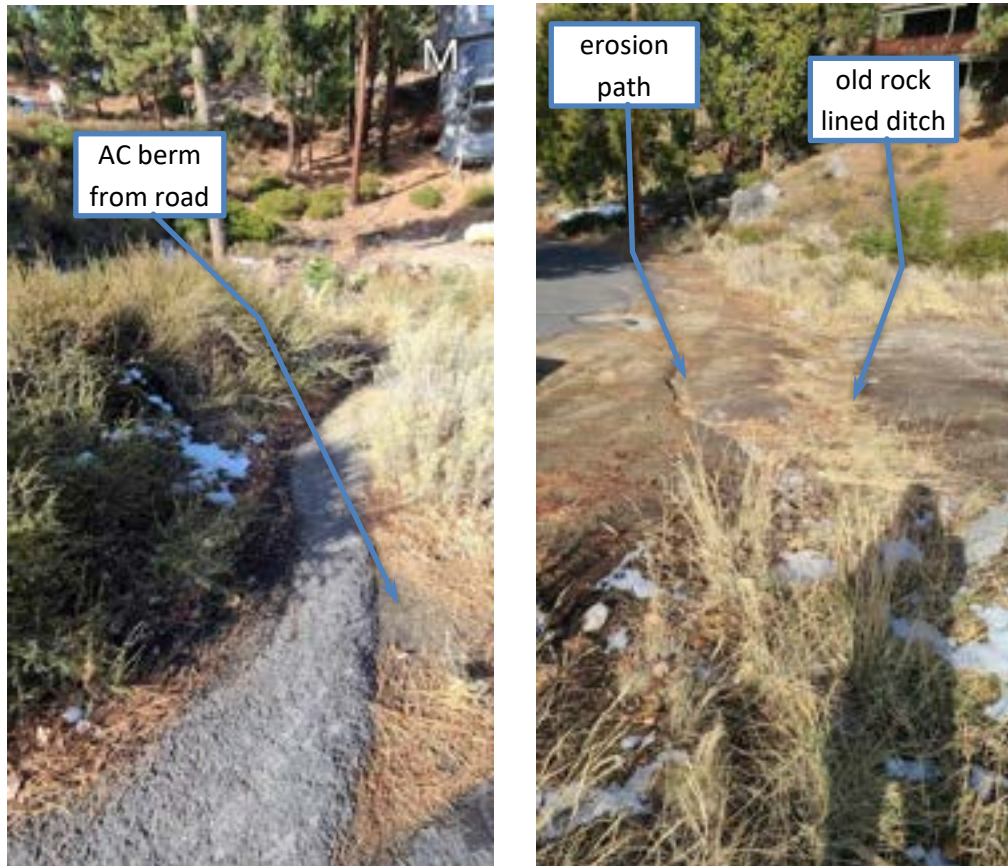
## Area of Concern #11

Road runoff from Winding Way and Pheasant Drive is conveyed into a drainage inlet which discharges to an asphalt curb on Wren Circle. The asphalt curb routes the runoff to a small basin. When the basin fills, the runoff overflows into a rock lined ditch along Wren Circle. Unfortunately, the 1354 Winding Way homeowner accesses the propane tank on the property at this location and drives over the rock lined ditch, which has compromised the ditch. Runoff now flows down Wren Circle creating a freeze/thaw condition over the road and is creating hillslope erosion at 285 Wren Circle due to an old failing AC berm.

Install new AC berm along Wren Circle and reestablish the rock lined ditch. Installing a driveway conveyance pipe (or larger ditch easily accessible for large vehicles) for access to the 1354 Winding Way property owner's propane tank will reduce maintenance on the rock lined channel.

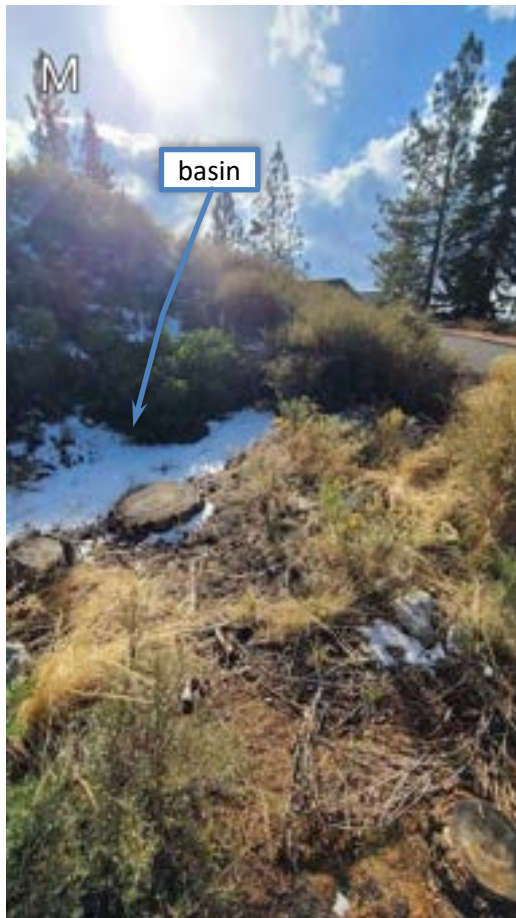
Small basin on Wren Circle is overwhelmed with runoff.

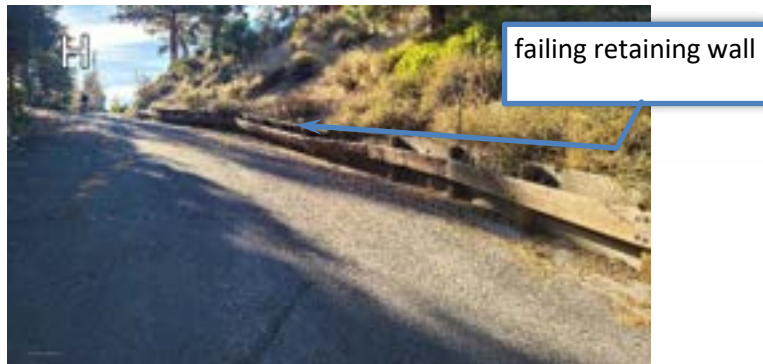
## Area of Concern #12

Failing 3-foot wood retaining wall along Robin Circle

Remove excess sediment from hillslope collapse and replace the wood retaining wall with a concrete retaining wall.

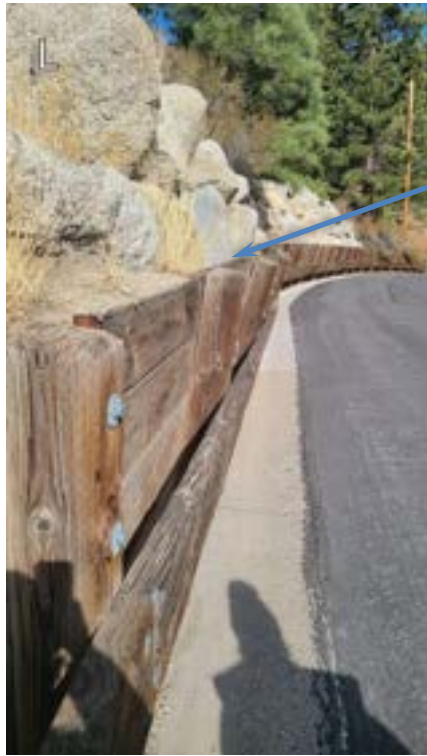
## Area of Concern #13

failing retaining wall

Failing 3-foot wood retaining wall along Wren Circle

Remove excess sediment from hillslope collapse, rebuild and replace the rock stabilization and install a concrete retaining wall.

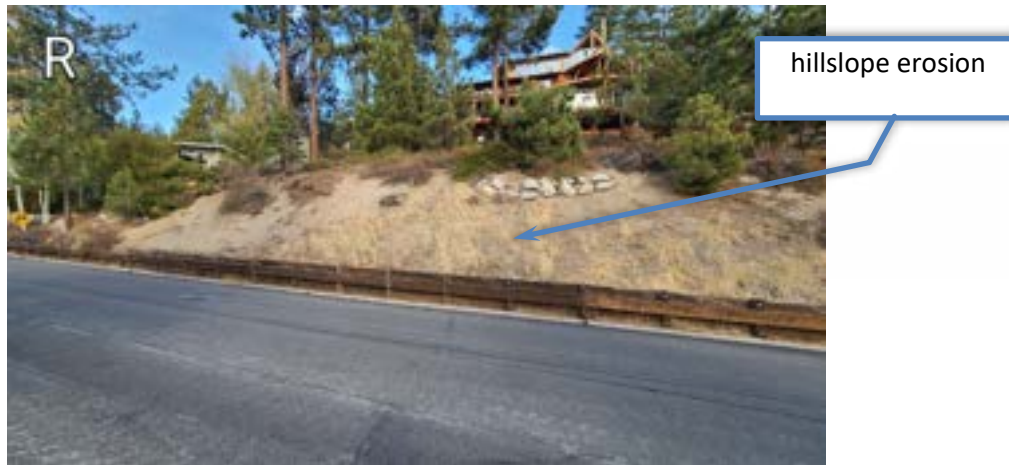
## Area of Concern #14

Eroded hillslope above 3-foot wood retaining wall along Cave Rock Drive.

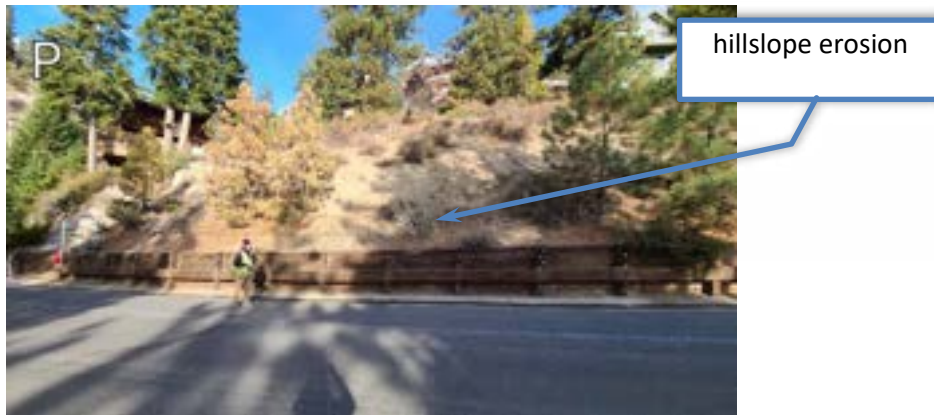
## Area of Concern #15

Eroded hillslope above 4-foot wood retaining wall along Cave Rock Drive.

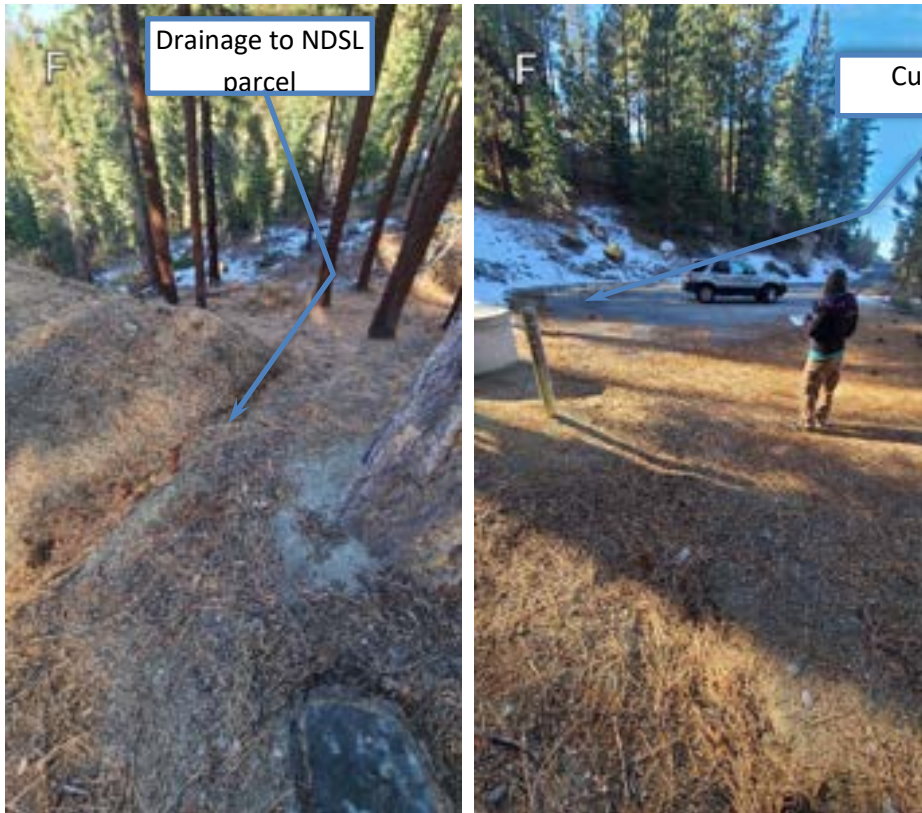
## Area of Concern #17

Chukar Drive road runoff and hillslope runoff pond in cul de sac, then overflows onto NDSL property (APN 1418-27-712-007) creating minimal erosion.
